INSPECTION REPORT PREPARED FOR:
Mr. Sample Report

PROPERTY:
158 Main Street
Garden City NY

Inspection Site: 158 Main Street
Garden City, NY 11530.

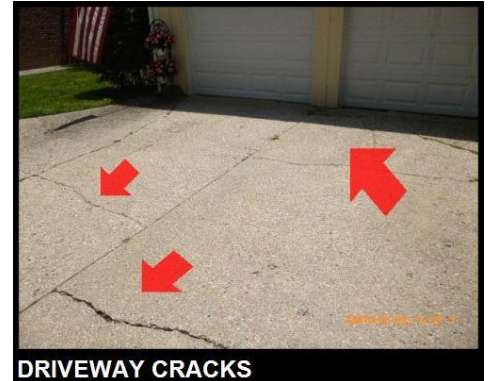
**DRIVEWAY CRACKS****2.5 Driveway Skirting**

Maintenance Advised - Surface is settling. Sealing the cracks with appropriate silicone or other suitable sealer is advised to prevent water intrusion. Trip hazard is found, the surface is not even at all areas.

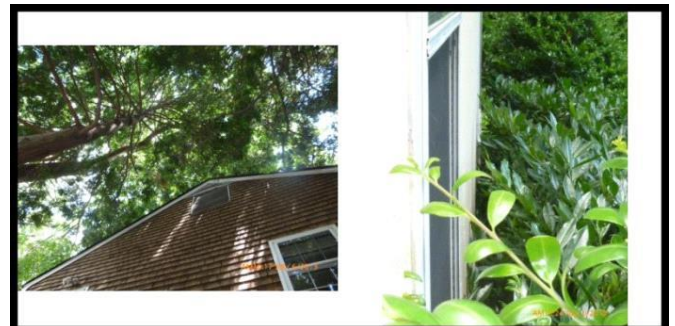
Maintenance Advised - Observed at various exterior walls. Tree limbs are in contact with the roof. Shrub is in contact with the structure. Damage to structural or surface components is possible with further growth of the vegetation. A qualified landscape contractor should be called to further evaluate and perform corrections as needed.

**TREES AND SHRUBS TOUCHING HOME**

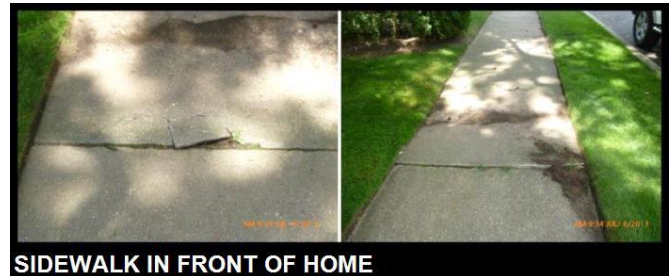
Safety Concern - Observed at the front sidewalk: Surface is deteriorated and settling. Walkway has movement. Trip hazard is found, the surface is not even at all areas. A qualified repair person should be called to further evaluate and perform corrections as needed.

SIDEWALK IN FRONT OF HOME

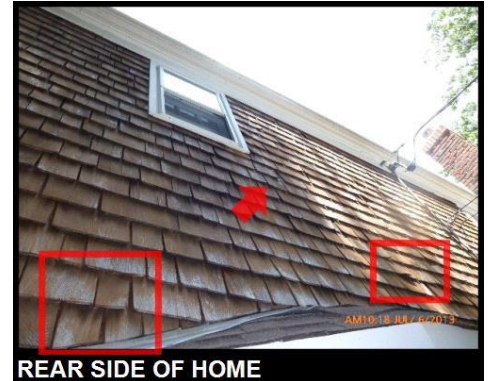
Maintenance Advised - Observed at the rear exterior wall: Cedar Shakes are missing, deteriorated, weathered, warped, and buckled. Some surface materials have deteriorated beyond repair and most likely will need to be replaced. Obtaining bids from appropriate persons is suggested for the purpose of determining how extensive repairs will be to bring into satisfactory condition.

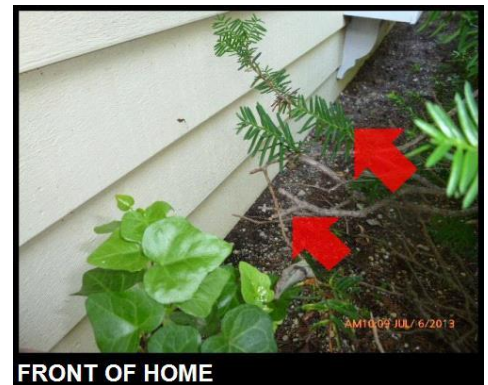
Maintenance Advised - Observed at, various areas of the exterior walls: Earth to wood contact may adversely impact the surface materials. General maintenance that is needed should easily be performed by a handy person.

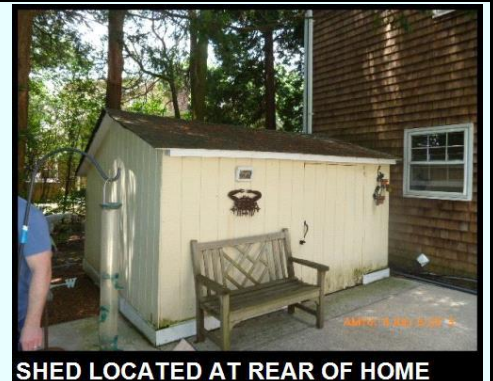
SHED LOCATED AT REAR OF HOME

Comments: Storage shed is in satisfactory condition. Shed has typical deterioration consistent with the age, normal wear and tear, and prolonged exposure to the weather and elements. Occasional power brushing and painting is recommended to extend the life of the external appearance.

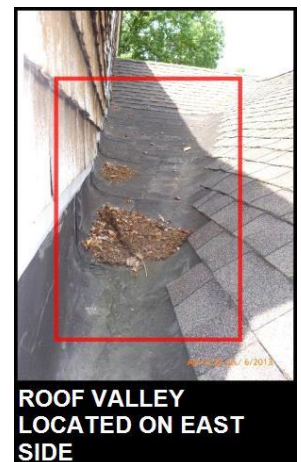
Attention Required - Observed, on the east side of the roof: Roofer recommended upgrading rolled composition roofing materials to metal at some point in the future to improve roof life and durability.

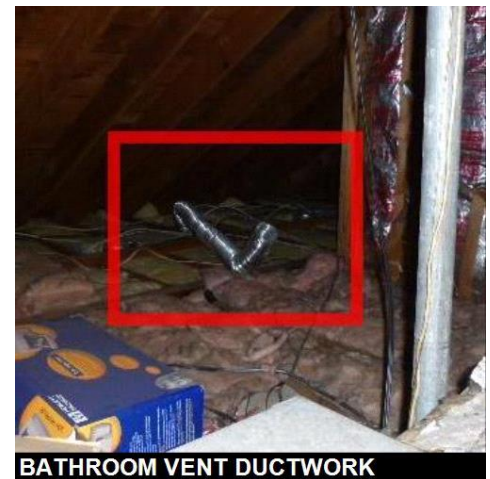
4.7 Ventilation

Deficiencies - Bathroom vent no ducted to home exterior. General repair that is needed should easily be performed by a handy person.

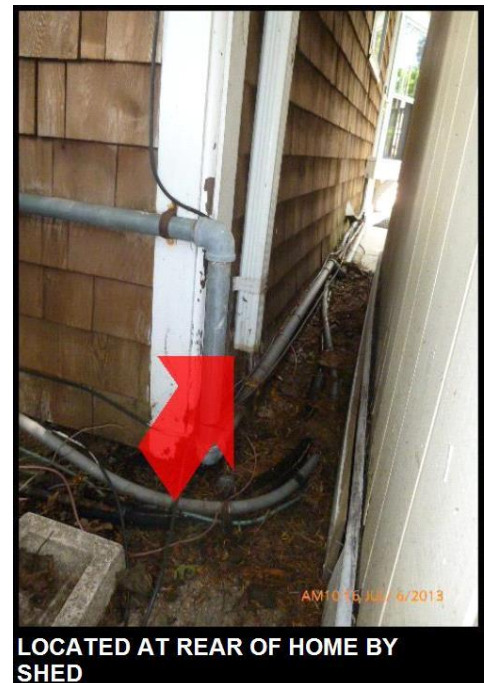
Maintenance Advised - Observed at various downspouts: Downspout extensions are not installed at downspout terminations. Installing extensions is suggested to effectively divert water away from the foundation. Downspout splash blocks are not effective. Water dispersed next to the foundation can cause the foundation to be adversely impacted because of water related conditions. Dispersing roof run off water a considerable distance away from the foundation is always best. Basic adjustments that is needed should easily be performed by a handy person.

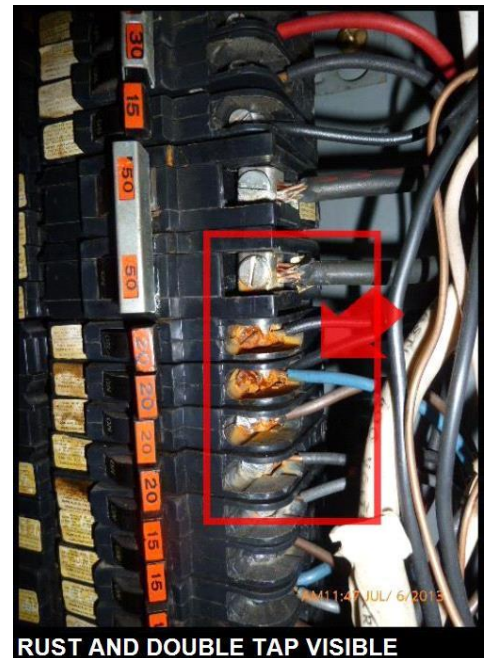
Deficiencies - Breaker double tapped into a single lug where only one wire should be connected. Evidence of rust is present on several breakers lugs. Unsafe conditions are found. Multiple wires that are connected to a single connection lug have the potential to overheat at the connection and can cause an electrical fire inside the panel. Due to the sensitive nature of electrical components and associated safety hazards working with electricity, and considering the long term integrity of the repairs, a licensed electrician is best suited to perform repairs no matter how trivial the repairs may seem. A qualified electrician should be called to further evaluate and perform corrections as needed.

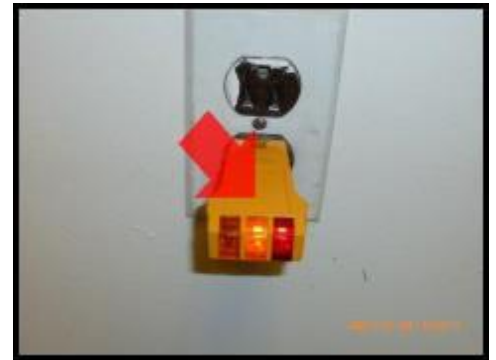
Maintenance Advised - Observed at various receptacles throughout the house: Interior receptacle wired incorrectly. Face plate is missing in receptacle in attic and various outlets did not function at inspection. Due to the sensitive nature of electrical components and associated safety hazards working with electricity, and considering the long term integrity of the repairs, a licensed electrician is best suited to perform repairs no matter how trivial the repairs may seem. A qualified electrician should be called to further evaluate and perform corrections as needed.

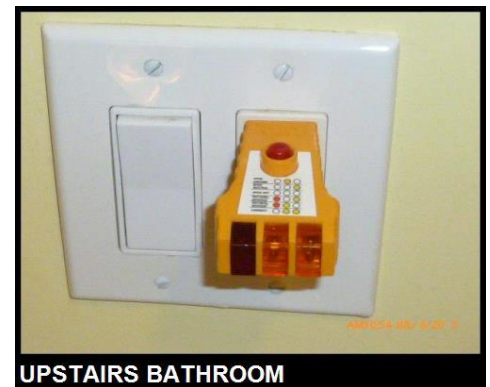
Deficiencies - Observed at various GFCI protected circuits: GFCI protected receptacles did not test correctly with a testing tool. Unsafe conditions are found. Due to the sensitive nature of electrical components and associated safety hazards working with electricity, and considering the long term integrity of the repairs, a licensed electrician is best suited to perform repairs no matter how trivial the repairs may seem. A qualified electrician should be called to further evaluate and perform corrections as needed.

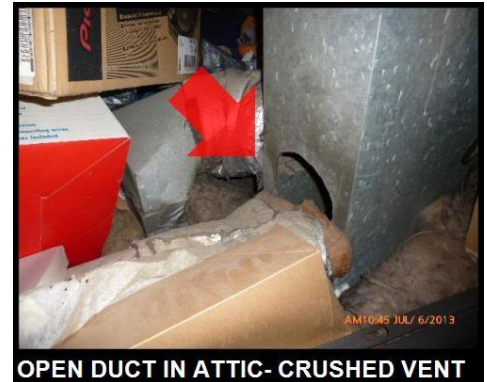
Deficiencies - Observed at the ducts in the attic and basement:
Distribution ducts are crushed. Upper level ductwork is not connected to system or blocked at some point. Suggest further evaluation by appropriate persons to perform a balance test of the distribution system. A qualified mechanical contractor should be called to further evaluate and perform corrections as needed.

OPEN DUCT IN ATTIC- CRUSHED VENT

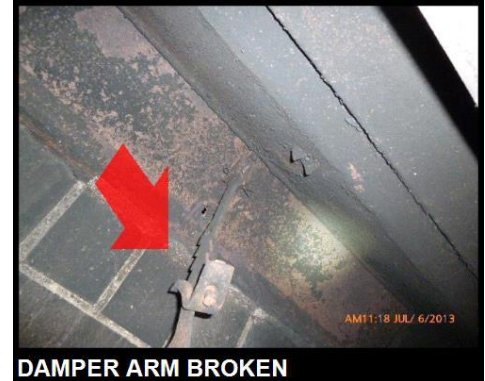
Deficiencies - Damper is broken. Unsafe conditions exist with this situation. A qualified fireplace technician should be called to further evaluate and perform corrections as needed.

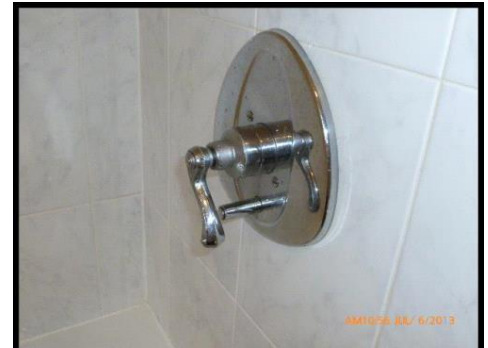
Deficiencies - Observed in the hallway bathroom. Shower diverter mechanism is damaged and not operating correctly. A qualified plumber should be called to further evaluate and perform corrections as needed.

**HALLWAY SHOWER BODY
INOPERABLE**

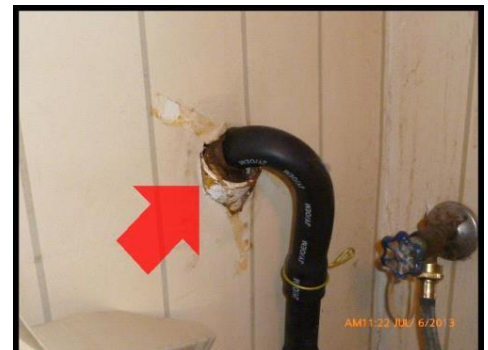
Deficiencies - Washer drains into PVC pipe line mounted in wall. Hose is bracketed or hard connected. Hose could come lose. General repair that is needed should easily be performed by a handy person.

WASHER DRAIN HOSE LOSE

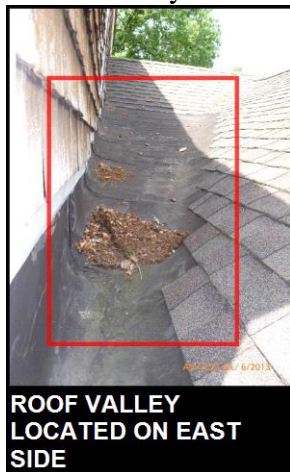
Attention Required - Observed, on the east side of the roof: Roofer recommended upgrading rolled composition roofing materials to metal at some point in the future to improve roof life and durability.

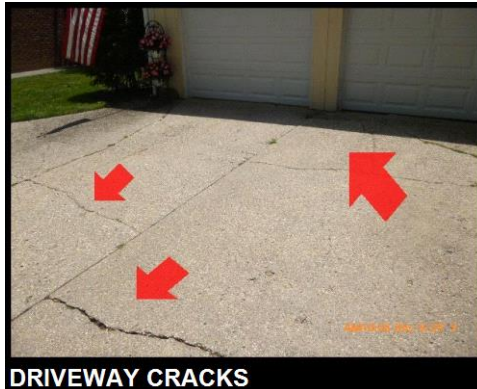
**DRIVEWAY CRACKS****2.5 Driveway Skirting**

Maintenance Advised - Surface is settling. Sealing the cracks with appropriate silicone or other suitable sealer is advised to prevent water intrusion. Trip hazard is found, the surface is not even at all areas.

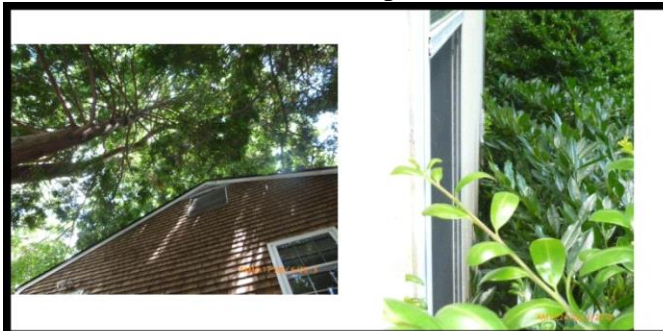
Maintenance Advised - Observed at various exterior walls. Tree limbs are in contact with the roof. Shrub is in contact with the structure. Damage to structural or surface components is possible with further growth of the vegetation. A qualified landscape contractor should be called to further evaluate and perform corrections as needed.

**TREES AND SHRUBS TOUCHING HOME**

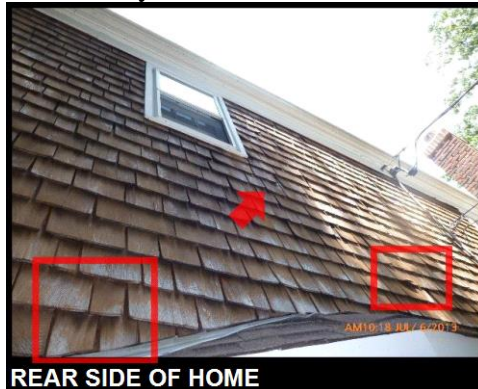
Maintenance Advised - Observed at the rear exterior wall: Cedar Shakes are missing, deteriorated, weathered, warped, and buckled. Some surface materials have deteriorated beyond repair and most likely will need to be replaced. Obtaining bids from appropriate persons is suggested for the purpose of determining how extensive repairs will be to bring into satisfactory condition.

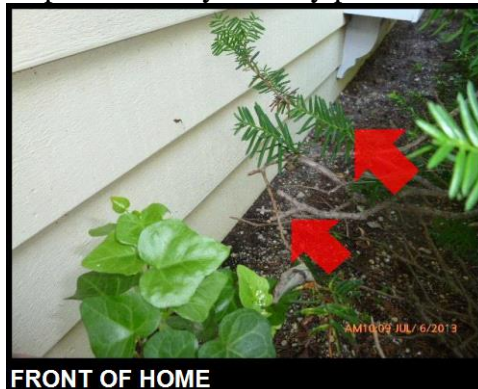
Maintenance Advised - Observed at, various areas of the exterior walls: Earth to wood contact may adversely impact the surface materials. General maintenance that is needed should easily be performed by a handy person.

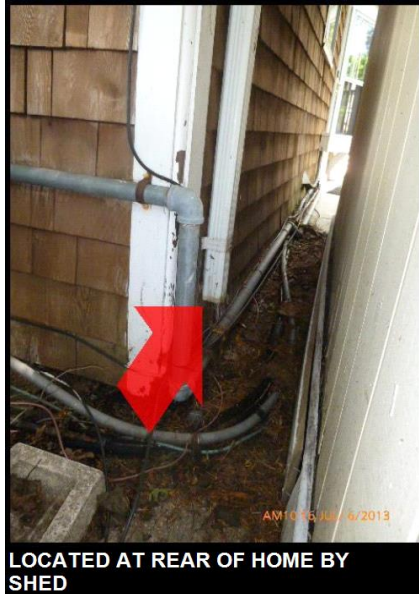
Maintenance Advised - Observed at various downspouts: Downspout extensions are not installed at downspout terminations. Installing extensions is suggested to effectively divert water away from the foundation. Downspout splash blocks are not effective. Water dispersed next to the foundation can cause the foundation to be adversely impacted because of water related conditions. Dispersing roof run off water a considerable distance away from the foundation is always best. Basic adjustments that is needed should easily be performed by a handy person.

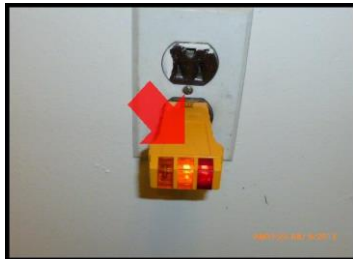
Maintenance Advised - Observed at various receptacles throughout the house: Interior receptacle wired incorrectly. Face plate is missing in receptacle in attic and various outlets did not function at inspection. Due to the sensitive nature of electrical components and associated safety hazards working with electricity, and considering the long term integrity of the repairs, a licensed electrician is best suited to perform repairs no matter how trivial the repairs may seem. A qualified electrician should be called to further evaluate and perform corrections as needed.

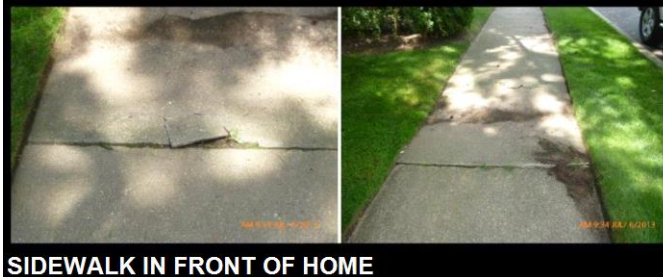
Safety Concern - Observed at the front sidewalk: Surface is deteriorated and settling. Walkway has movement. Trip hazard is found, the surface is not even at all areas. A qualified repair person should be called to further evaluate and perform corrections as needed.

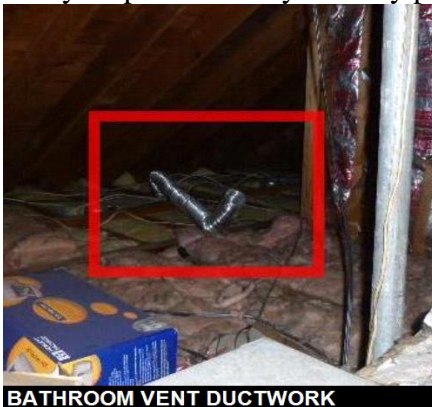
Deficiencies - Bathroom vent no ducted to home exterior. General repair that is needed should easily be performed by a handy person.

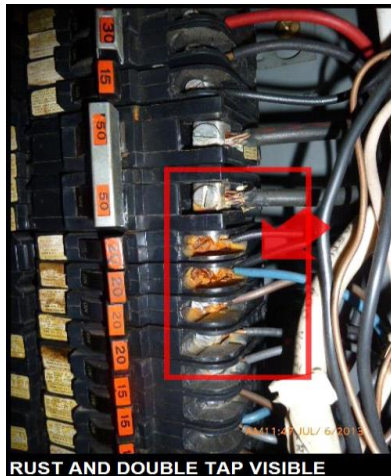
Deficiencies - Breaker double tapped into a single lug where only one wire should be connected. Evidence of rust is present on several breakers lugs. Unsafe conditions are found. Multiple wires that are connected to a single connection lug have the potential to overheat at the connection and can cause an electrical fire inside the panel. Due to the sensitive nature of electrical components and associated safety hazards working with electricity, and considering the long term integrity of the repairs, a licensed electrician is best suited to perform repairs no matter how trivial the repairs may seem. A qualified electrician should be called to further evaluate and perform corrections as needed.

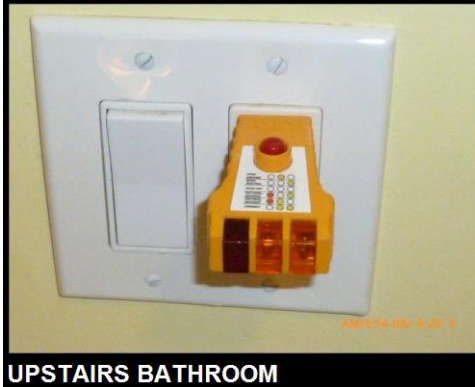
Deficiencies - Observed at various GFCI protected circuits: GFCI protected receptacles did not test correctly with a testing tool. Unsafe conditions are found. Due to the sensitive nature of electrical components and associated safety hazards working with electricity, and considering the long term integrity of the repairs, a licensed electrician is best suited to perform repairs no matter how trivial the repairs may seem. A qualified electrician should be called to further evaluate and perform corrections as needed.

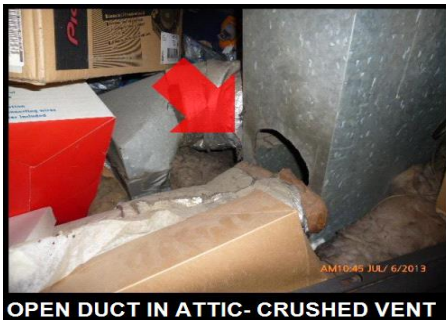
Deficiencies - Observed at the ducts in the attic and basement: Distribution ducts are crushed. Upper level ductwork is not connected to system or blocked at some point. Suggest further evaluation by appropriate persons to perform a balance test of the distribution system. A qualified mechanical contractor should be called to further evaluate and perform corrections as needed.

**OPEN DUCT IN ATTIC- CRUSHED VENT**

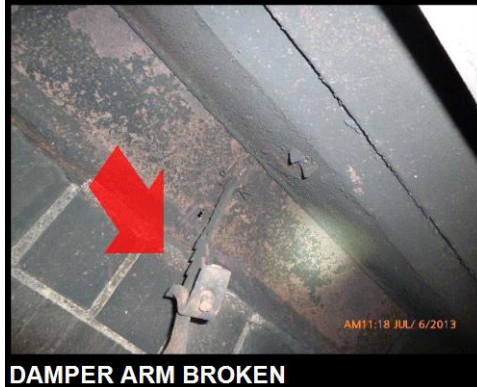
Deficiencies - Damper is broken. Unsafe conditions exist with this situation. A qualified fireplace technician should be called to further evaluate and perform corrections as needed.

**DAMPER ARM BROKEN**DOORS

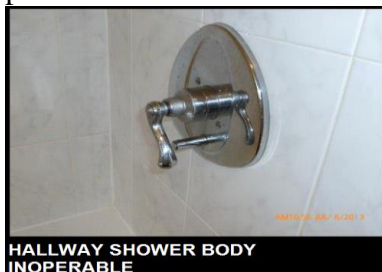
Deficiencies - Observed in the hallway bathroom. Shower diverter mechanism is damaged and not operating correctly. A qualified plumber should be called to further evaluate and perform corrections as needed.

**HALLWAY SHOWER BODY
INOPERABLE**

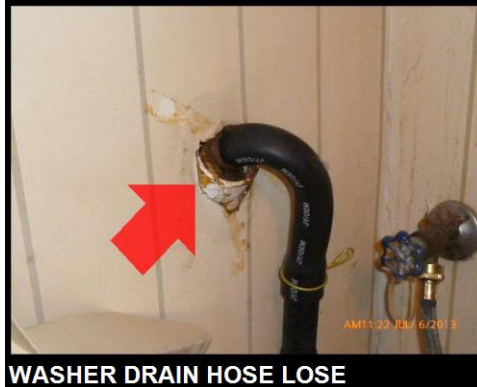
Deficiencies - Washer drains into PVC pipe line mounted in wall. Hose is bracketed or hard connected. Hose could come lose. General repair that is needed should easily be performed by a handy person.

**WASHER DRAIN HOSE LOSE**
