INSPECTION REPORT PREPARED FOR:
Mr. Sample Report

PROPERTY:
158 Main Street
Garden City NY

Inspection Site: 158 Main Street
Garden City, NY 11530.

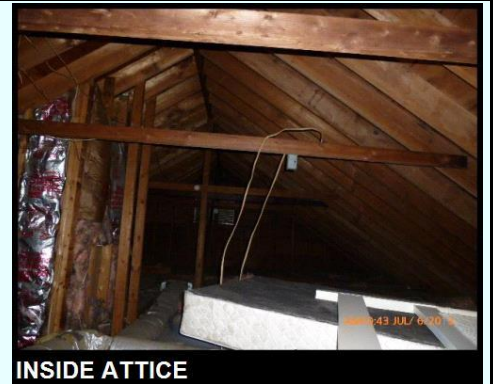
Comments: Roof structure is in satisfactory condition. Vents where visible appear to be secure and unobstructed. Insulation where visible is in satisfactory condition with appropriate coverage. Insulation R-value (resistance to heat loss) varies with the type and distribution methods of the materials. As a general rule of thumb, cellulose based insulation has roughly R-3.2 per inch, thus 10 inches is approximately R-32 while fiberglass is slightly lower at 3.0 per inch, thus 10 inches is approximately R-30. Other types of insulation materials have a wide range of R-value ratings. Obtaining information from the manufacturer is necessary to determine R-value ratings of insulation materials such as styrofoam.

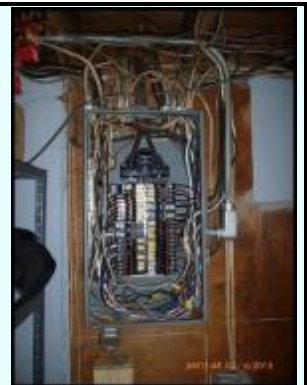
Comments: The service entrance and related components are in satisfactory condition. The service entrance is generally comprised of overhead cables with conduit (service lateral), electric meters, cabinets and the main shut off device(s). Rust is present on the exterior of the cabinet, typical for the age.

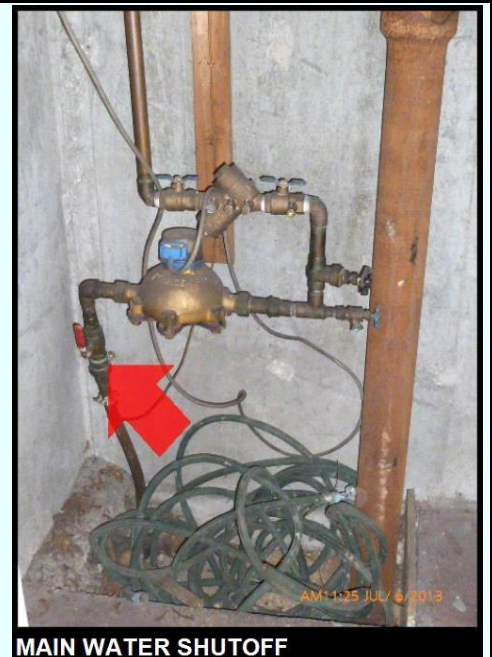
Comments: The plumbing supply and drainage systems appear to be in satisfactory condition. Functional water flow and drainage observed at the tested plumbing fixtures throughout the house. Main water shut off valve is accessible.

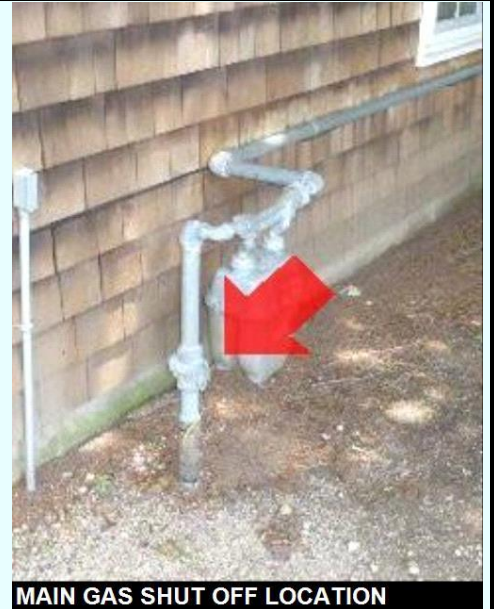
MAIN GAS SHUT OFF LOCATION

Comments: The fuel supply system is in satisfactory condition, there is no evidence of leaks found. Because of the safety aspect with distributing gas fuel, the local gas company can enforce new rules or regulations when deemed necessary. With this in mind, as the property ages, the homeowner can be forced to upgrade existing situations even if these situations were acceptable when they were installed. As a result, gas service may not be approved for distribution to the property until these situations are corrected. Predicting future requirements by the gas company or municipality is outside the scope of this inspection.

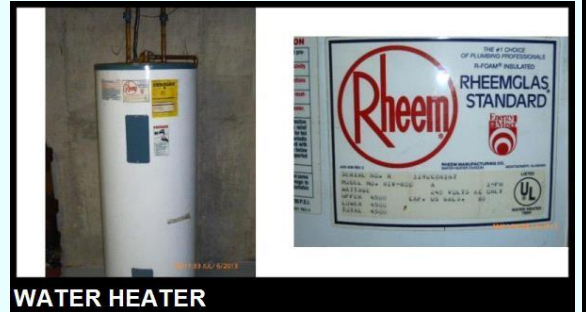
Brand Name & Age: Rheem. Estimated age is 21 years. The design life is typically 20 years.

Comments: The water heating equipment is in satisfactory condition and heating water as intended. Expansion tanks are suggested with newer water heaters when connected into a municipal water system.

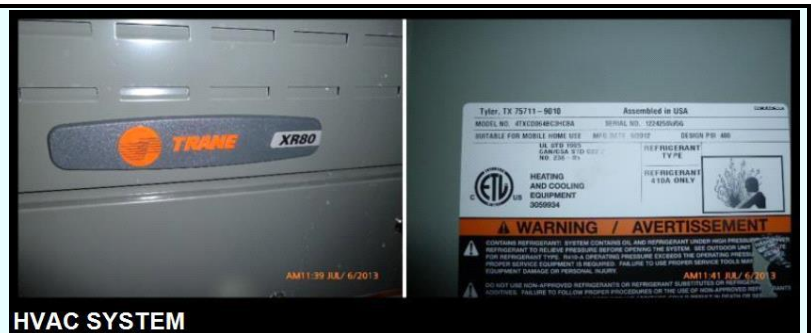
Comments: The HVAC equipment is in good condition at most areas with exceptions noted below. There is a permanently installed heating and cooling source found in all habitable rooms.
